Re: Notice of Violation  
Compliance Evaluation Inspection  
EPA ID No.: WID006078844

## RCRA COMPLIANCE EVALUATION INSPECTION REPORT

**SITE NAME:** Pentair

**DATE OF INSPECTION:** September 12, 2012

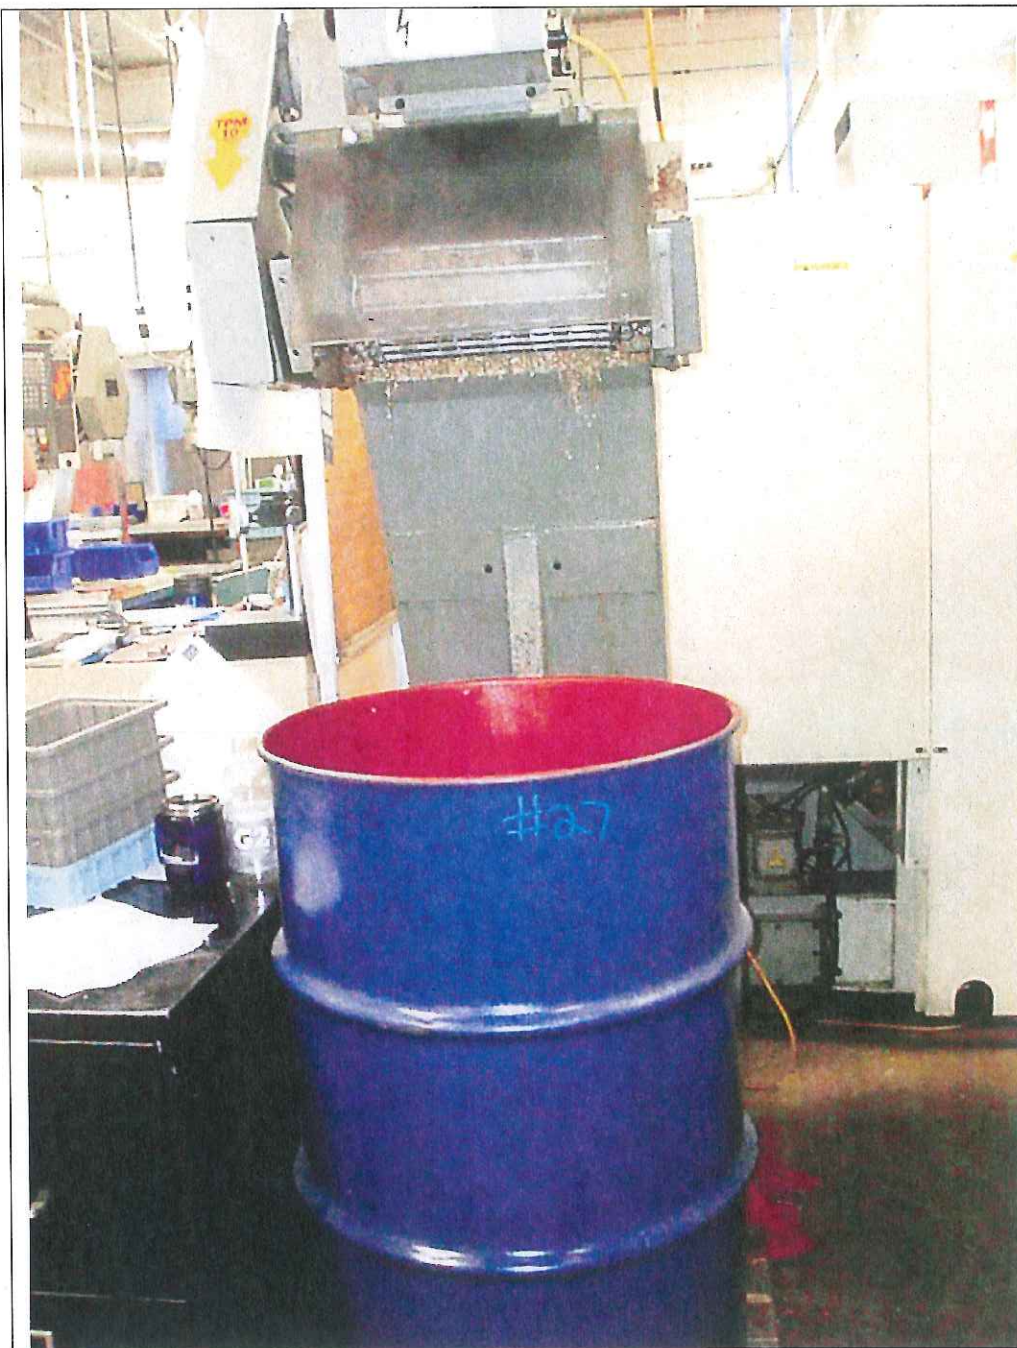
P9110068

**Subject:** Brass

cuttings are

conveyed out of

a metalworking

machine fluid

reservoir. Drips

of

metalworking

fluid fall into

the drum along

with cuttings.

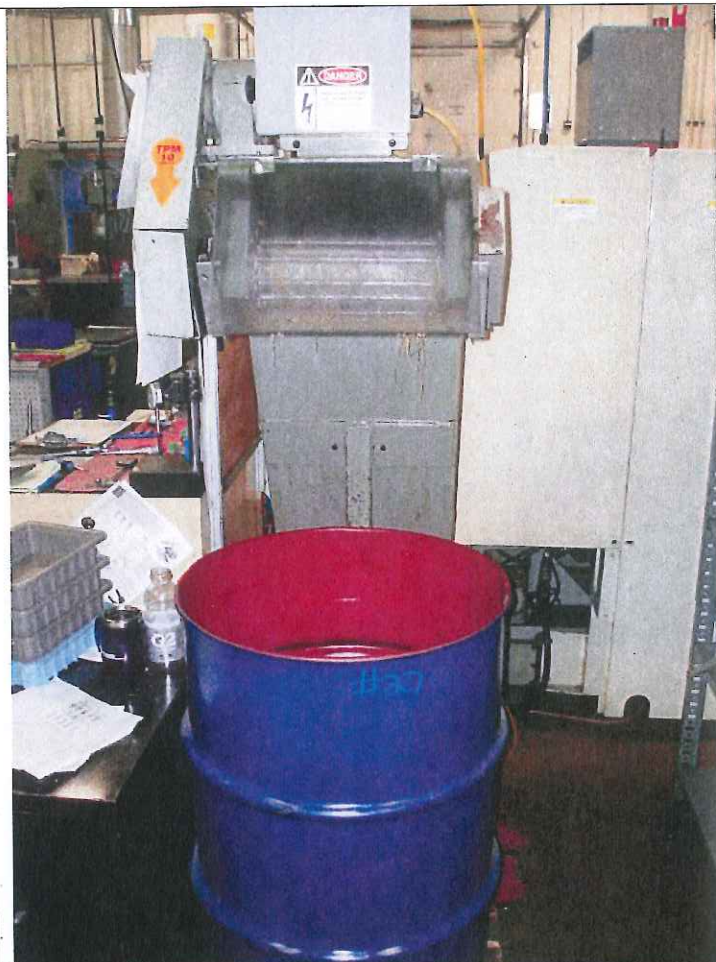
**Picture #:**  
P9110069  
**Date:** 9/11/12,  
11:11 a.m.  
**Photographer:**  
Sue Brauer  
**Location:**  
Pentair,  
WID006078844  
**Subject:** This is  
the same  
machine as  
P9110068,  
slightly  
different  
exposure.

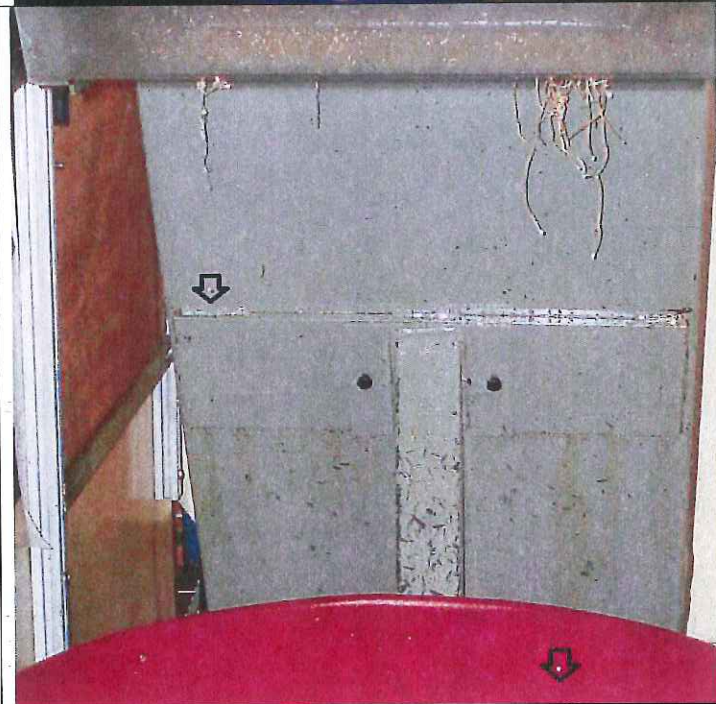
**Picture #:**  
P9110069  
enlarged and  
cropped. The  
added black  
arrows help to  
distinguish two  
falling drops of  
metalworking  
fluid.

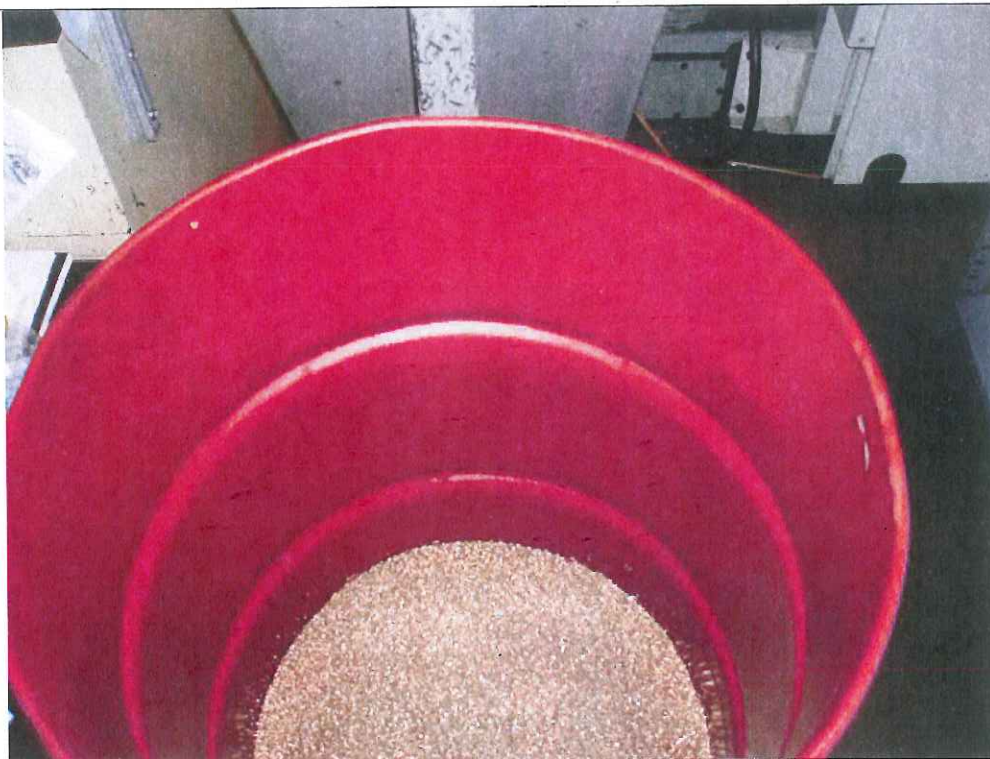
**Picture #:**  
P9110070

**Subject:** This is  
the drum  
marked #27 in  
the previous two  
photos. This  
drum receives  
brass chips and  
oil emulsion  
drips. I could  
not see a free-  
flowing phase of  
metalworking  
fluid in the  
drum. The drum  
was not labeled  
“used oil.”

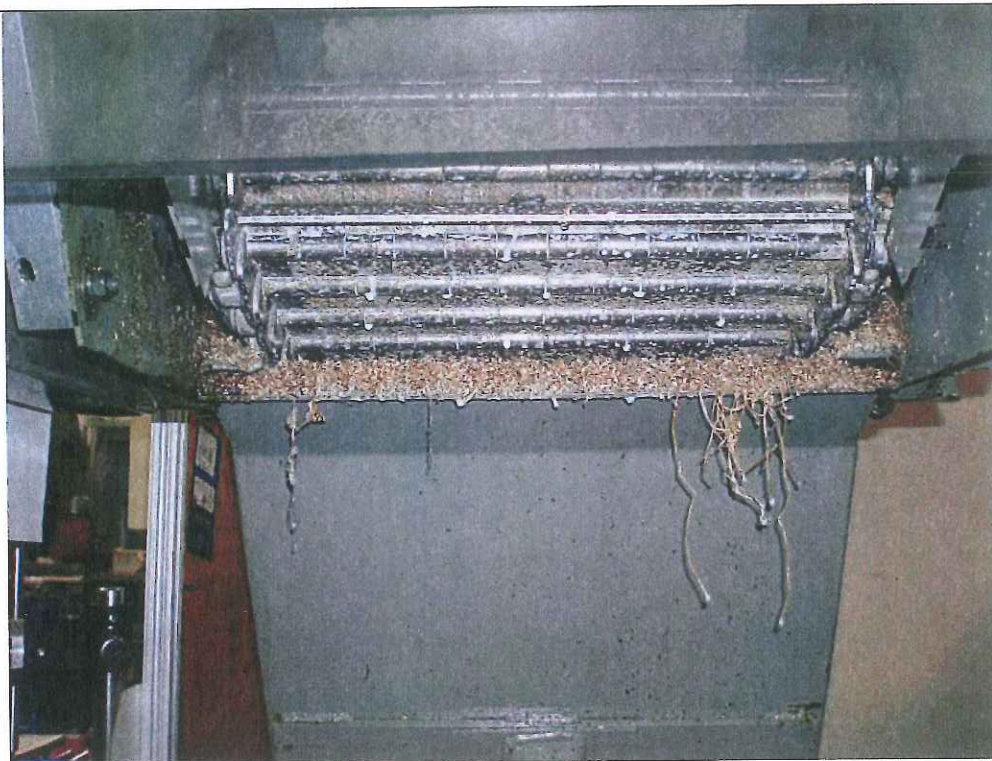
**Picture #:**  
P9110071  
**Date:** 9/11/12  
11:12 a.m.  
**Photographer:**  
Sue Brauer  
**Location:**  
Pentair,  
WID  
006078844,  
west side of the  
Supermarket  
area on site  
map.  
**Subject:** Many  
drops of  
metalworking  
fluid ride along  
the chip  
conveyor over  
the receiving  
drum (#27  
shown in  
previous photos)  
of cuttings.

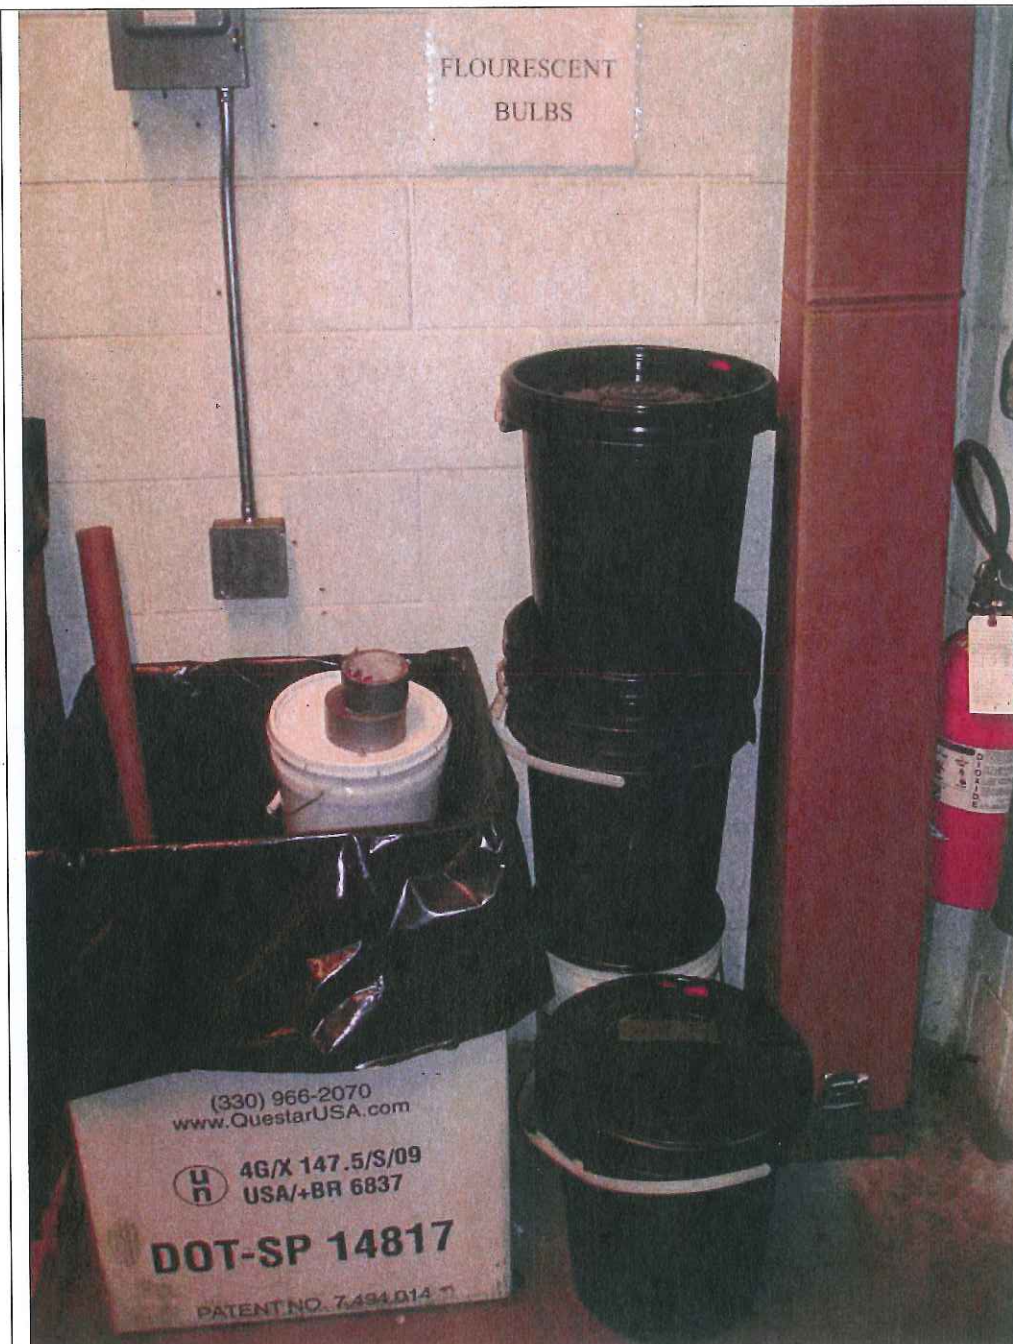
**Picture #:**  
911072  
**Date:** 9/11/12  
11:13 a.m.  
**Photographer:**  
Sue Brauer  
**Location:**  
Pentair  
WID  
006078844,  
small room  
adjacent to  
Supermarket  
and  
Subassembly  
areas on site  
map.  
**Subject:**  
Universal waste  
fluorescent  
bulbs are stored  
in closed  
containers in a  
labeled location.

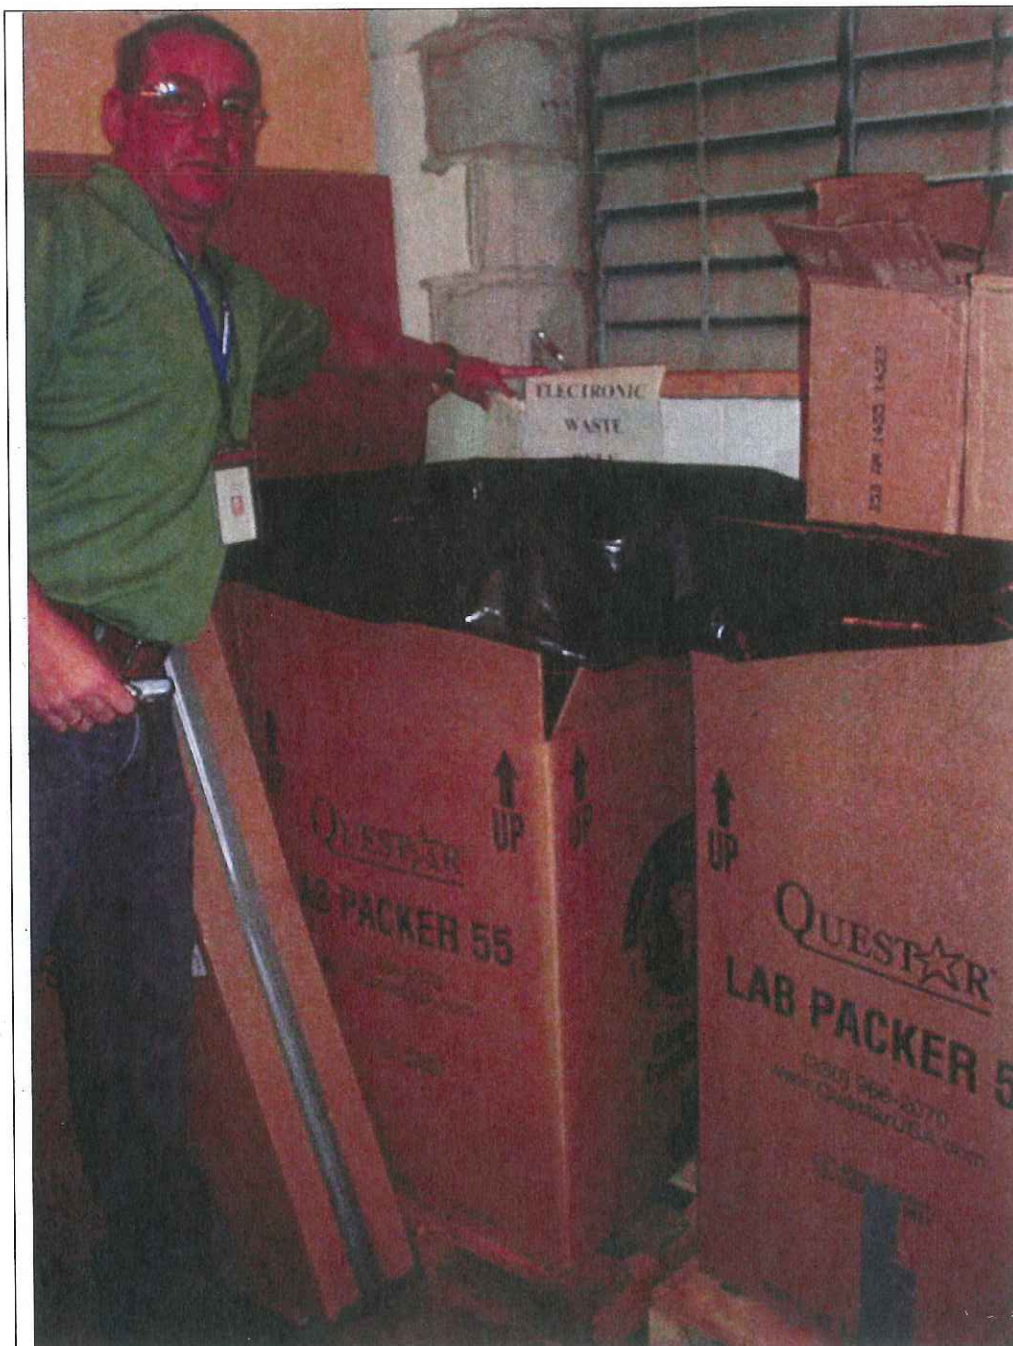
**Picture #:**  
P9110073  
**Date:** 9/11/12  
11:14 a.m.  
**Photographer:**  
Sue Brauer  
**Location:**  
Pentair  
WID  
006078844,  
small room  
adjacent to  
Supermarket and  
Subassembly  
areas on site  
map.  
**Subject:**  
Electronic waste  
is managed as  
universal waste.  
One box used for  
universal waste  
fluorescent tubes  
is open at the  
end. See the box  
flaps at the upper  
right edge of this  
photo. Mr. Bob  
Hintz is pictured.

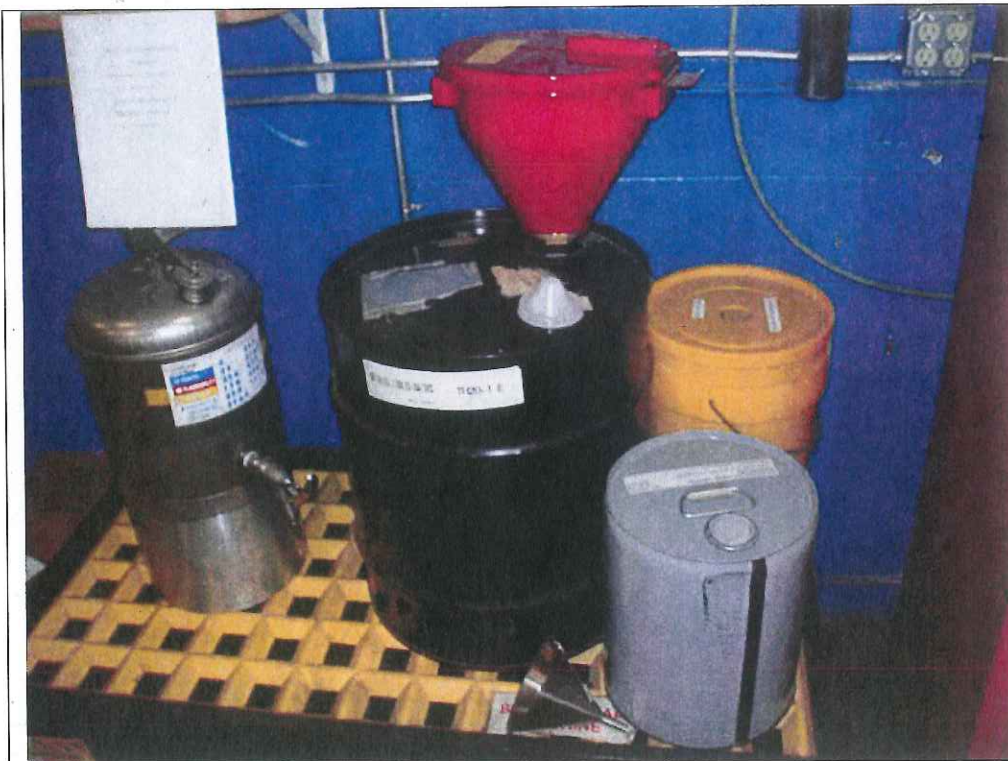
**Picture #:**  
P9110074  
**Date:** 9/11/12  
11:17 a.m.  
**Photographer:**  
Sue Brauer  
**Location:**  
Pentair, WID  
006078844  
Subassembly  
Area  
**Subject:** Product  
methylene  
chloride solvent  
management  
practice.

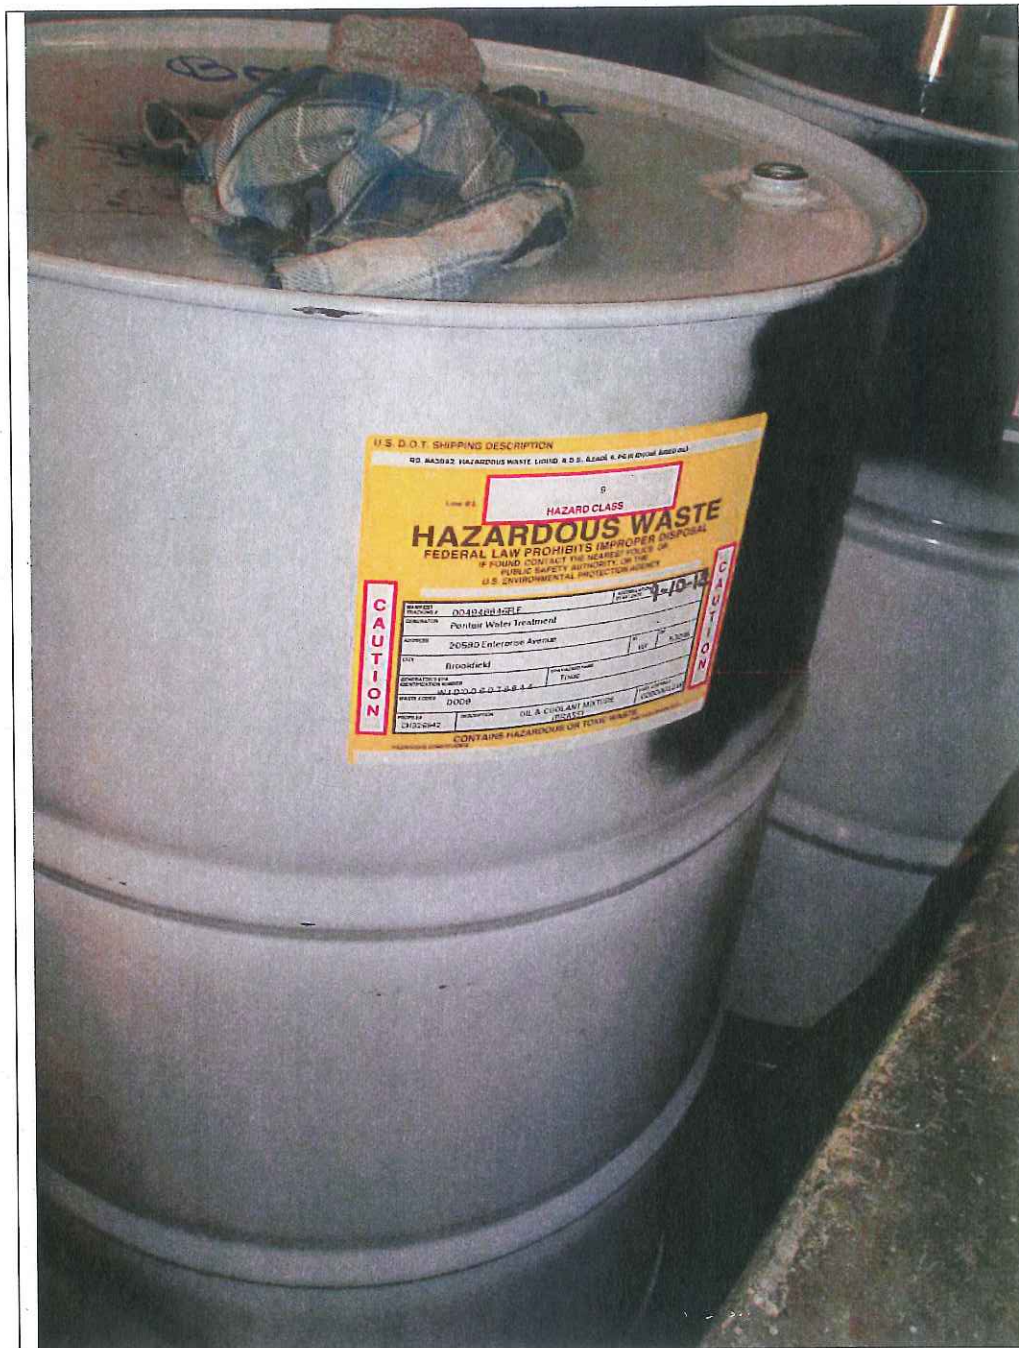
**Picture #:**  
P9110075  
**Date:** 9/11/12  
11:24 a.m.  
**Photographer:**  
Sue Brauer  
**Location:**  
Pentair, WID  
006078844, in  
Machine Shop  
on site map.  
**Subject:** This  
drum of  
Hazardous waste  
is labeled with  
the manifest  
number,  
004948846 FLE.  
The  
accumulation  
period began on  
9/10/12. The  
contents are oil  
and coolant,  
(brass) and  
identified with  
hazardous waste  
code D008.

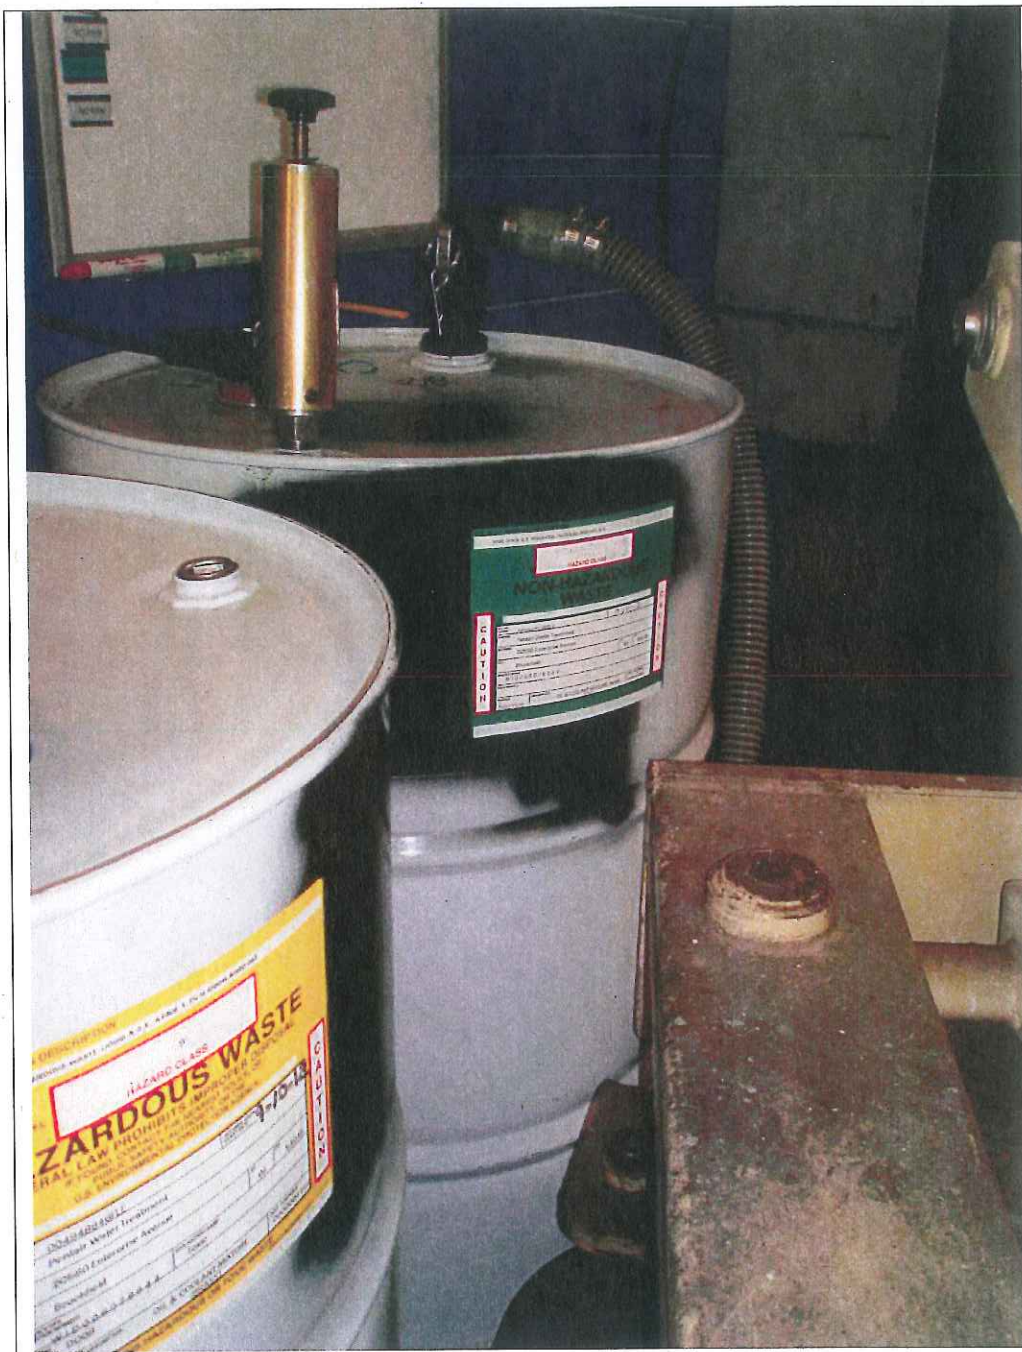
**Picture #:**  
P9110076  
**Date:** 9/11/12  
11:24 a.m.  
**Photographer:**  
Sue Brauer  
**Location:**  
Pentair, WID  
006078844, in  
Machine Shop  
on site map.  
**Subject:** This  
drum contains  
spent  
metalworking  
fluid from iron  
or steel cuttings.  
It is labeled  
"Non-hazardous  
waste." The  
gray hose  
connected to the  
drum bung hole  
is part of the  
cuttings draining  
system. The  
other drum  
attachment  
connects to a  
plant vacuum  
line. The drum  
to the left was  
the subject in  
photo P9110075.  
A man lift  
(lower right of  
photo) was here  
for lighting tube  
replacement.

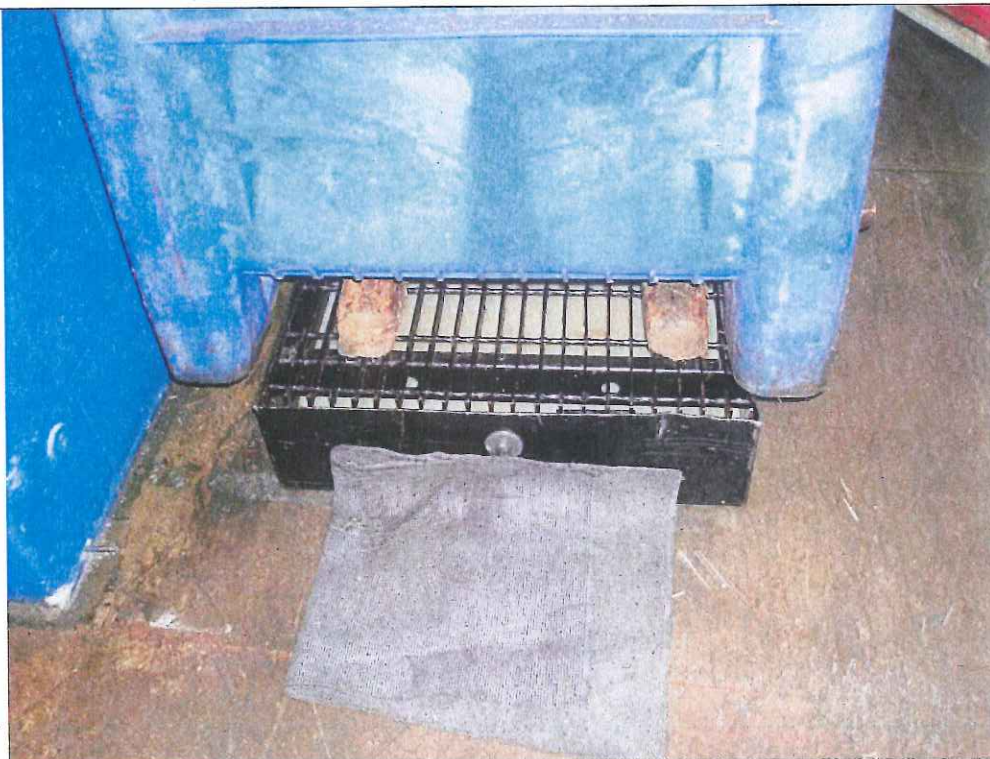
**Picture #:**  
P9110077

**Subject:**  
The blue tote has  
a capacity of  
about 400  
gallons. Pentair  
uses gravity to  
physically  
separate  
metalworking  
fluid from the  
cuttings in it. It  
is stored over  
containment  
with absorbent  
pads available  
for transfer  
spills.

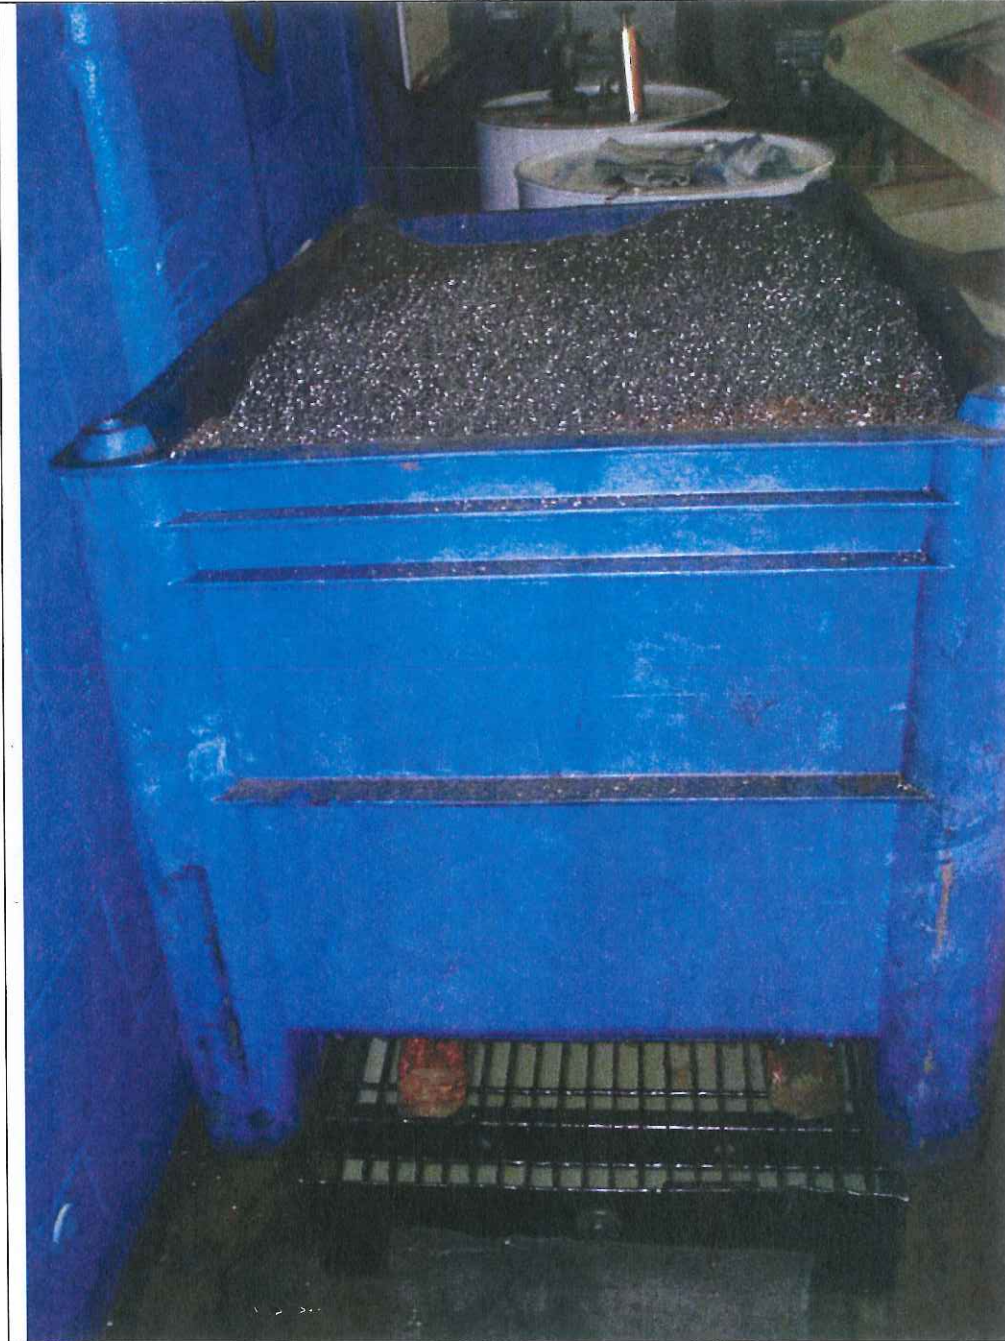
P9110078

**Subject:** This is  
an overview of  
the cuttings  
draining area  
looking east.

The blue tote of  
cuttings is the  
same tote as in  
P9110077. The  
drums of spent  
metalworking  
fluid were in  
photos  
P9110075 and  
P9110076.

According to  
Pentair staff, it  
takes about three  
days to fill this  
tote with  
cuttings. It  
drains for 24  
hours.

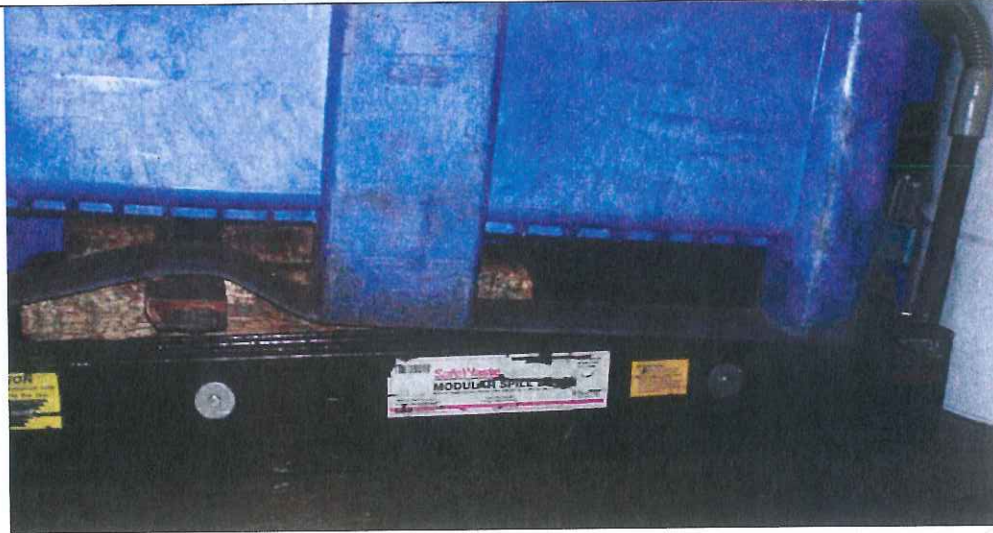
**Picture #:**  
cropped from  
P9110079  
**Date:** 9/11/12,  
11:27 a.m.  
**Photographer:**  
Sue Brauer  
**Location:**  
Pentair, WID  
006078844,  
Machine Shop  
area on site map.  
**Subject:** The  
gray piping from  
the right front  
corner of the  
modular spill  
basin was  
connected to the  
nonhazardous  
waste drum seen  
in P9110076.

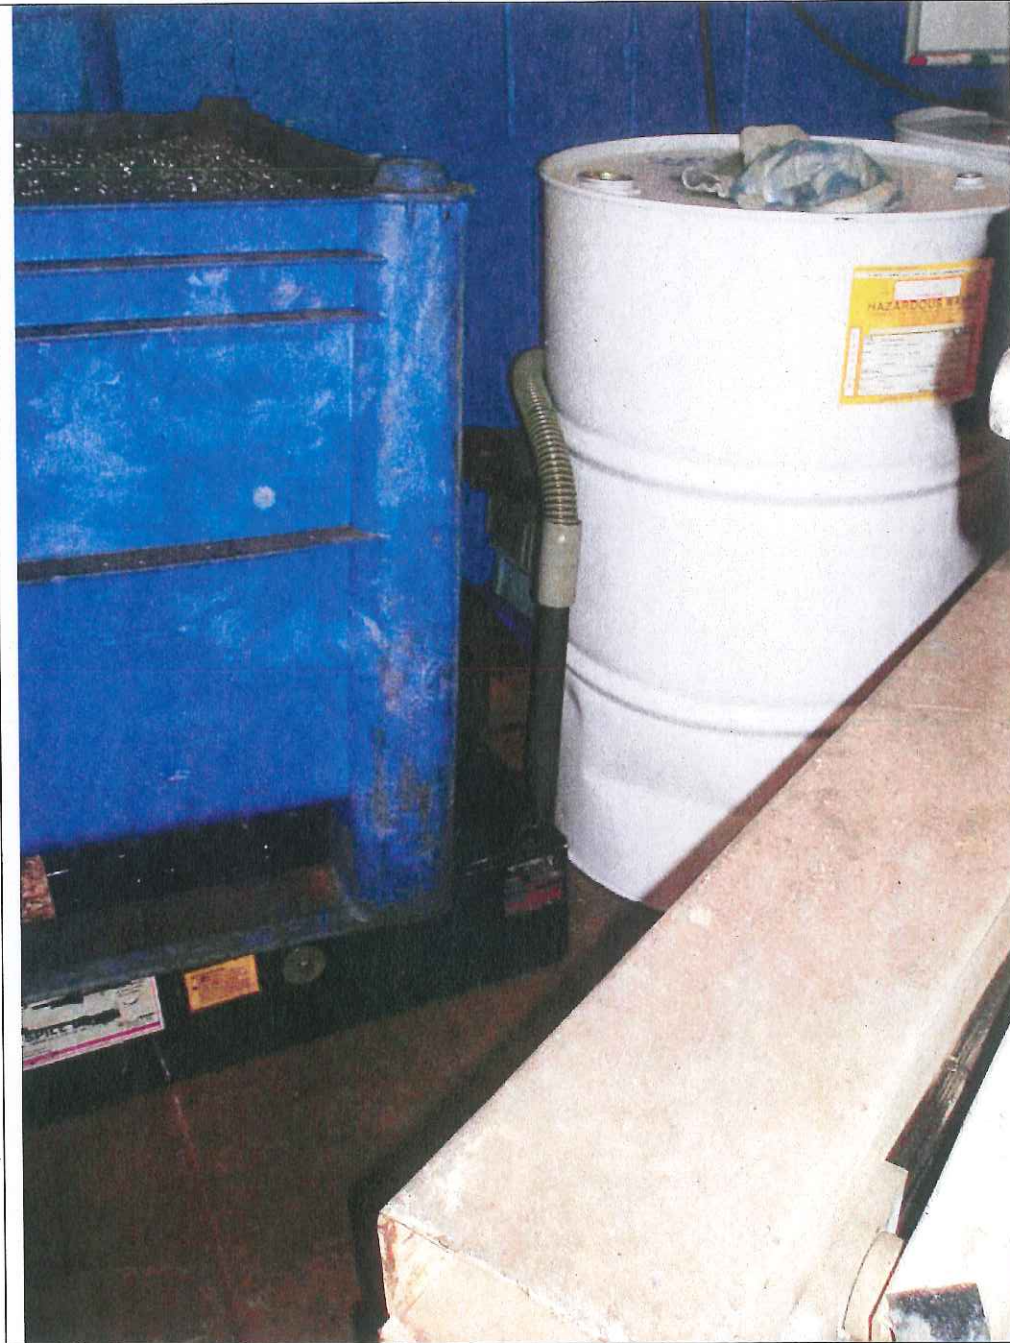
**Picture #:**  
P9110080  
**Date:** 9/11/12,  
11:27 a.m.  
**Photographer:**  
Sue Brauer  
**Location:**  
Pentair, WID  
006078844,  
machine shop on  
site map.  
**Subject:** Better  
photo of spent  
metalworking  
fluid piping  
from iron or  
steel cuttings to  
drums than in  
P9110079. Man  
lift in bottom  
right of picture.

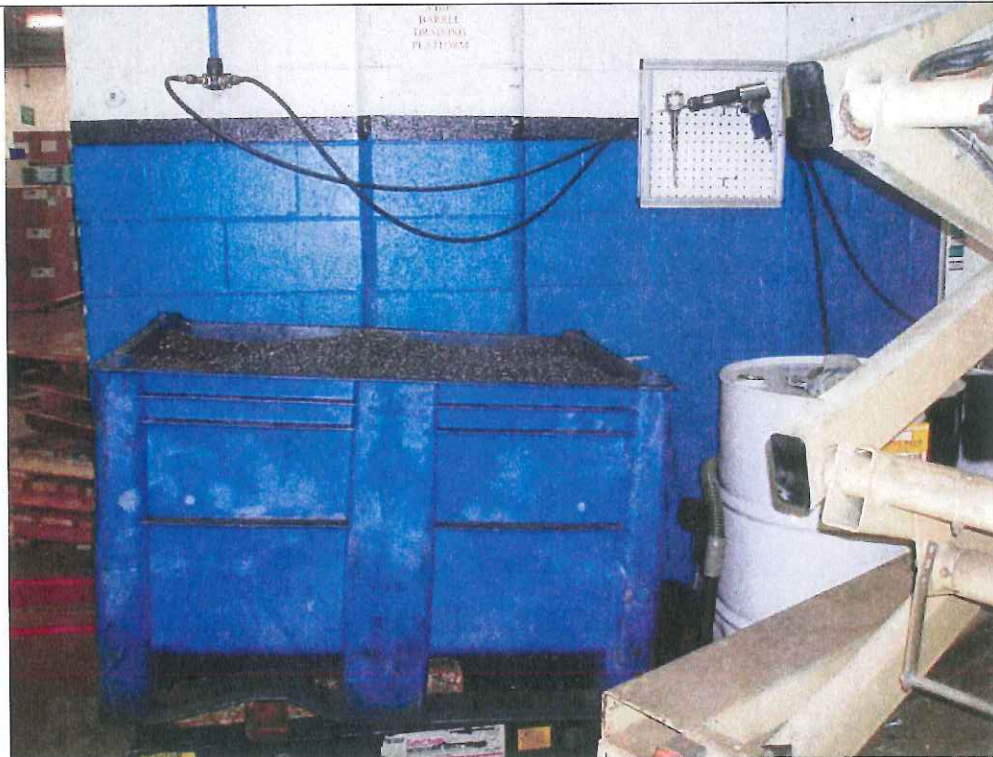
**Picture #:** P9110081  
**Date:** 9/11/12, 11:28 a.m.  
**Photographer:** Sue Brauer  
**Location:** Pentair, WID 006078844  
**Subject:** Overview of chip barrel draining area looking north. Removal of oil from basin below the tote ("barrel" on sign) is by building vacuum. Note the black hoses attaching vacuum system pipe on wall to drums.

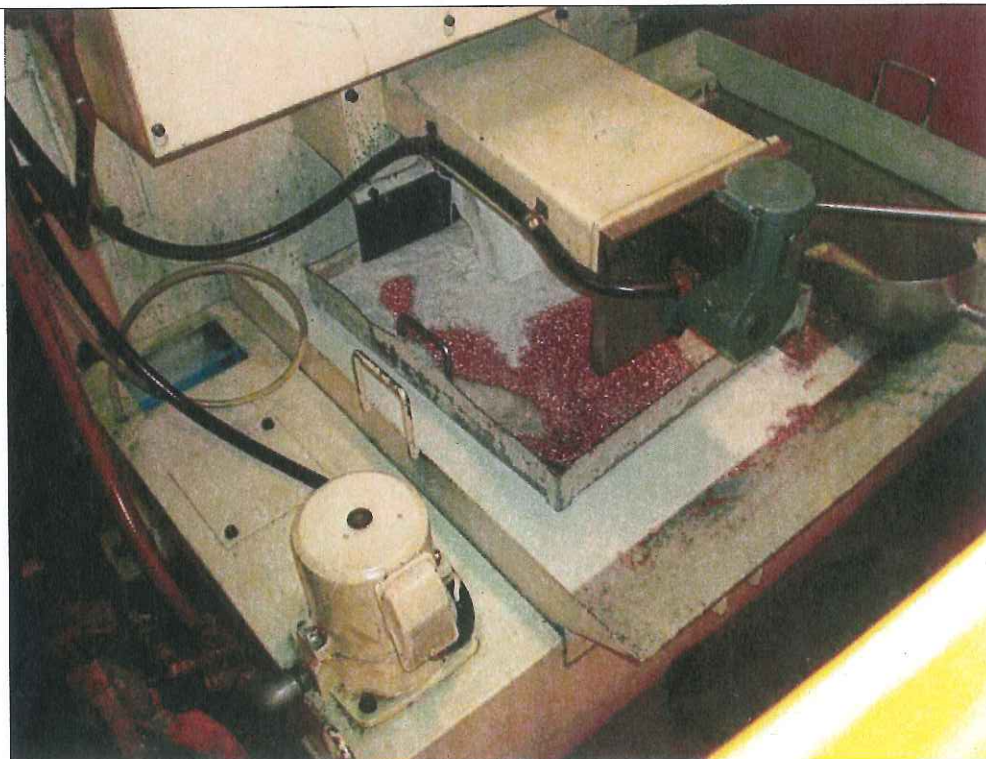
**Picture #:** P911082  
**Date:** 9/11/12, 11:35 a.m.  
**Photographer:** Sue Brauer  
**Location:** Pentair, WID 006078844, machine shop on site map.  
**Subject:** Brass metalworking fluid, an emulsion coolant, is shown here. The cuttings are removed a couple of times per shift according to Pentair staff.

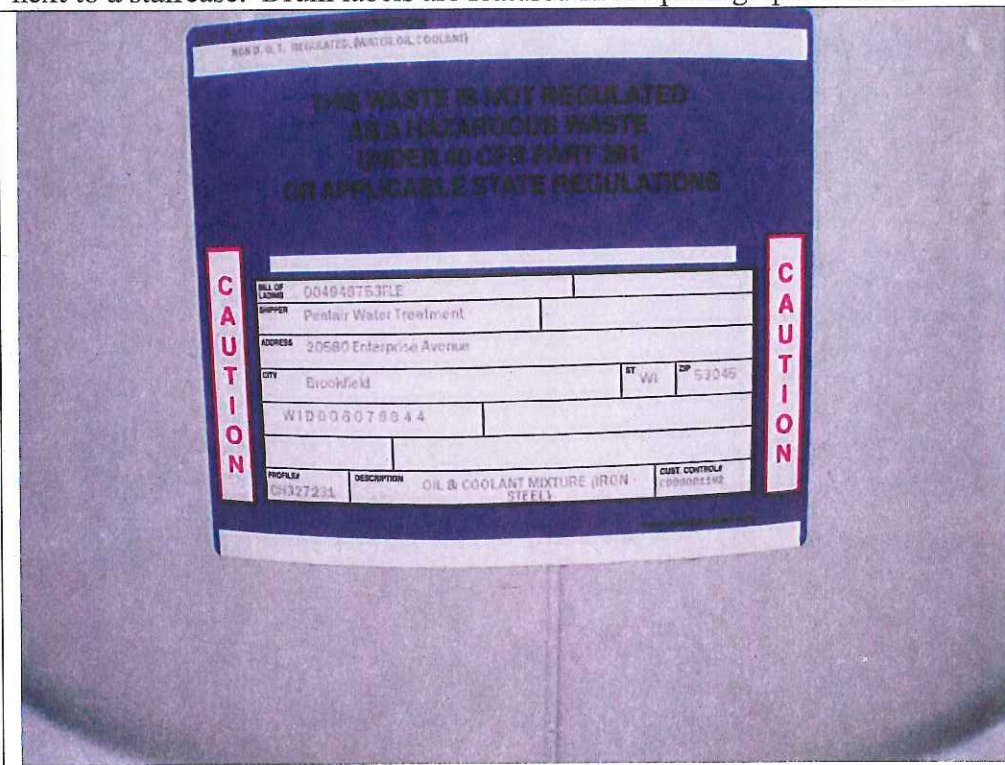
| | | <b>Picture #:</b><br>P9110083 |

| | | <b>Subject:</b> Spent<br>metalworking<br>fluid (water, oil,<br>coolants) is<br>labeled<br>nonhazardous.<br>The description<br>clarifies that the<br>coolant mixture<br>is from<br>machining "iron-<br>steel." |

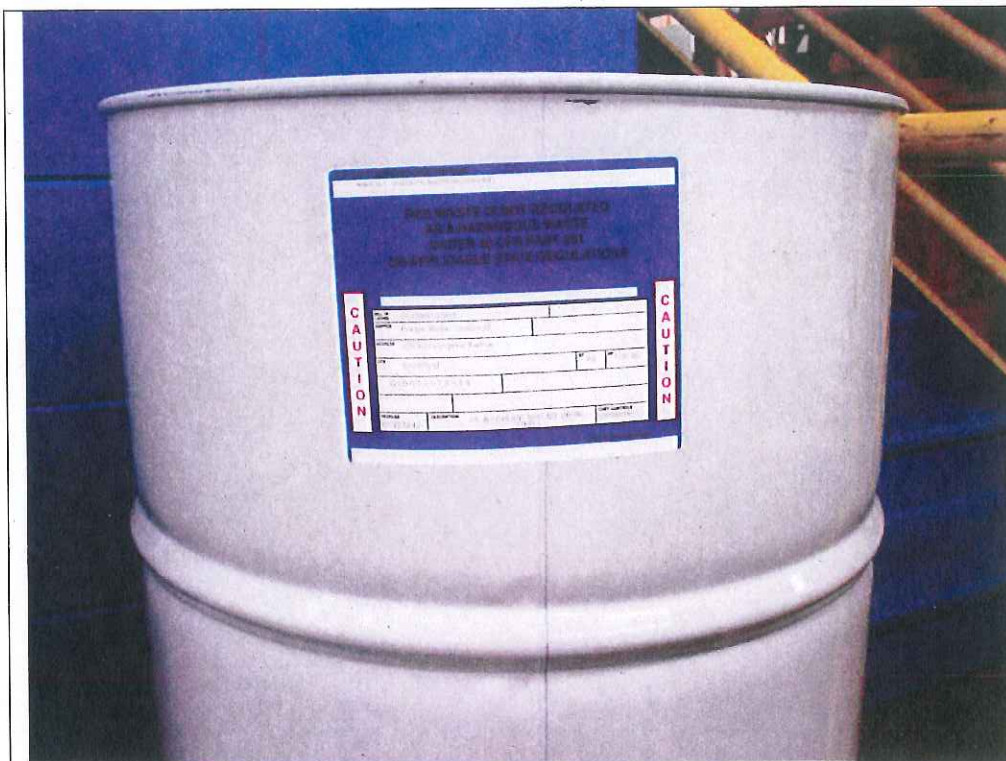
**Picture #:**  
 P9110084  
**Date:** 9/11/12  
**Photographer:**  
 Sue Brauer  
**Location:**  
 Pentair, WID  
 006078844  
**Subject:** Same  
 drum as in  
 P911084, with  
 surroundings to  
 establish  
 location.

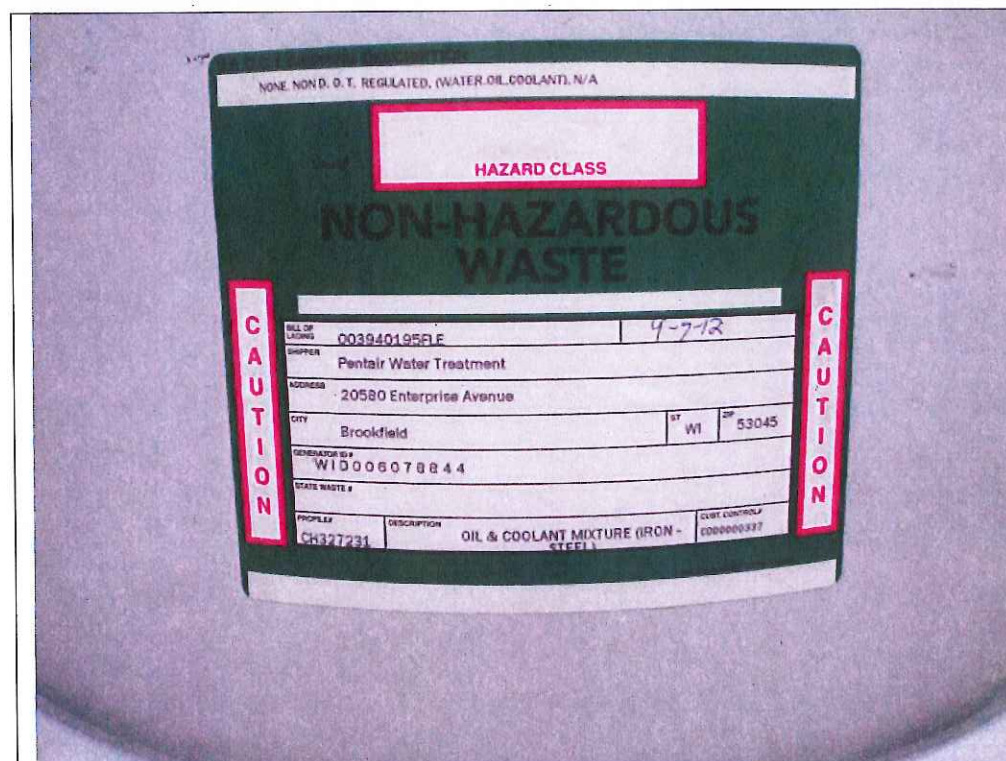
**Picture #:**  
 P9110085  
**Date:** 9/11/12  
**Photographer**  
 : Sue Brauer  
**Location:**  
 Pentair, WID  
 006078844  
**Subject:** Same  
 nonhazardous  
 wastestream  
 profile # as in  
 P9110084 but  
 different style  
 label.
